Technical *Info*

Timing belt kit CT 939 K1- 5 based on example:
VW / Audi 2.4/ 2.5 TDI 5 cyl.

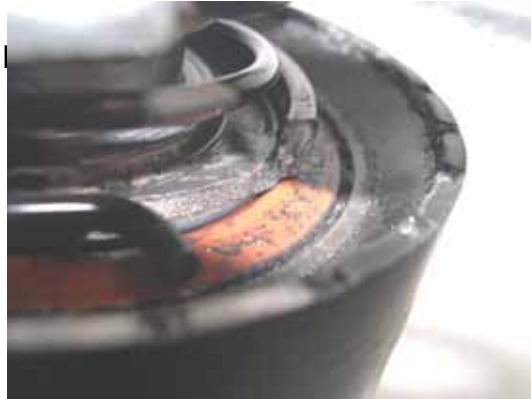
A cast part has broken off the tension roller or the spring is broken.
→ The belt jumped over it and the tension roller does not work.
(Fig.1)

The oil contamination caused the failure of the roller (excessive oscillation of the spring). It must always be checked to ensure that the shaft sealing rings on the crankshaft/camshaft function properly. If required they must be replaced.
The sealing on the oil-pump housing may have to be replaced.

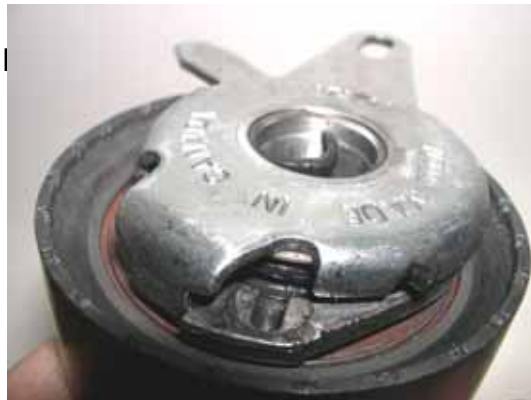
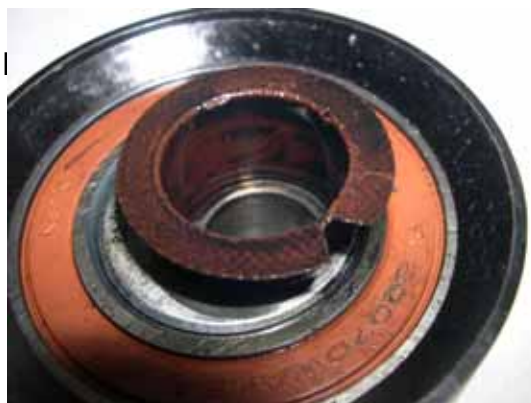
The tension roller is obviously contaminated with oil. The Teflon-coated friction pulley does not work.
(Fig. 2 / Fig. 3)
